Engineering Fraud Claims

12 August 2021

G SUJENTHIRAN

CHIMNEY COLLAPSE

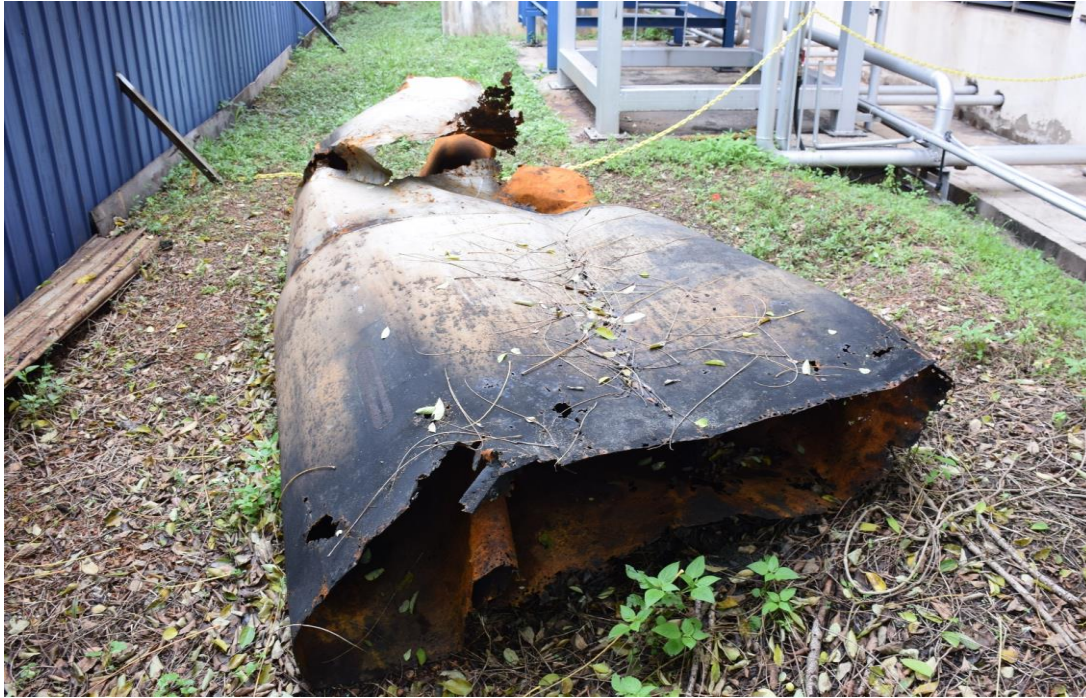
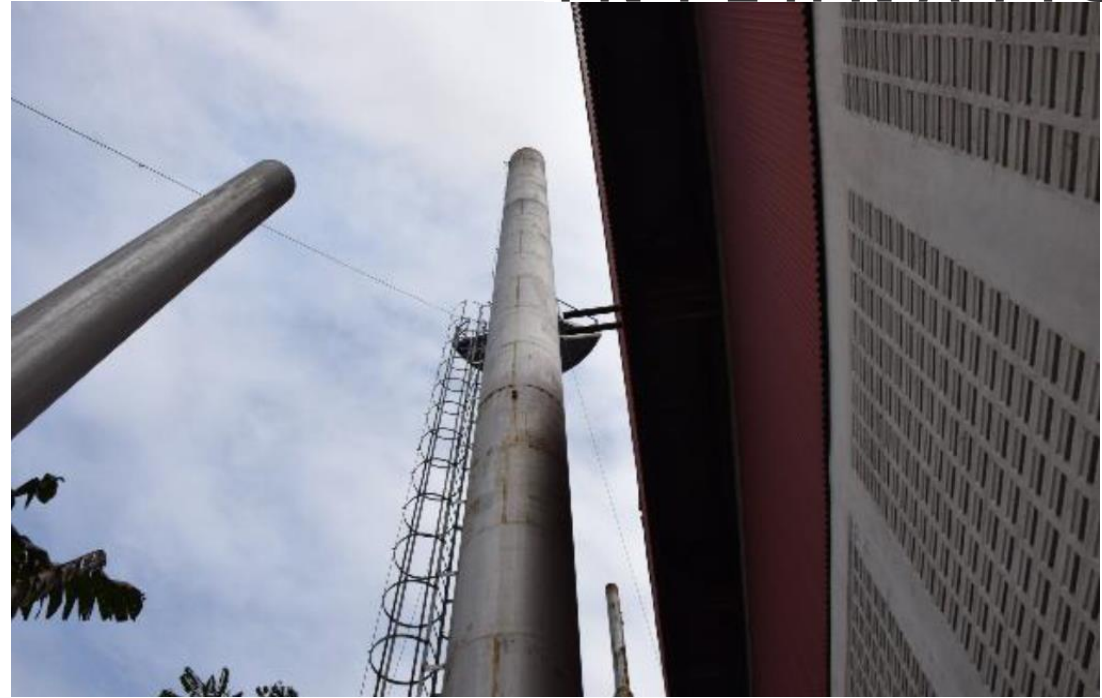
- Windstorm reportedly caused, top section of chimney to collapse, ducting to tear a part, ID Fan support frames broken and ID Fan misaligned
- Picture above shows broken and collapsed top section of the chimney
- Chimney top section and ducting are situated outdoors while ID fan and its associated items are indoors

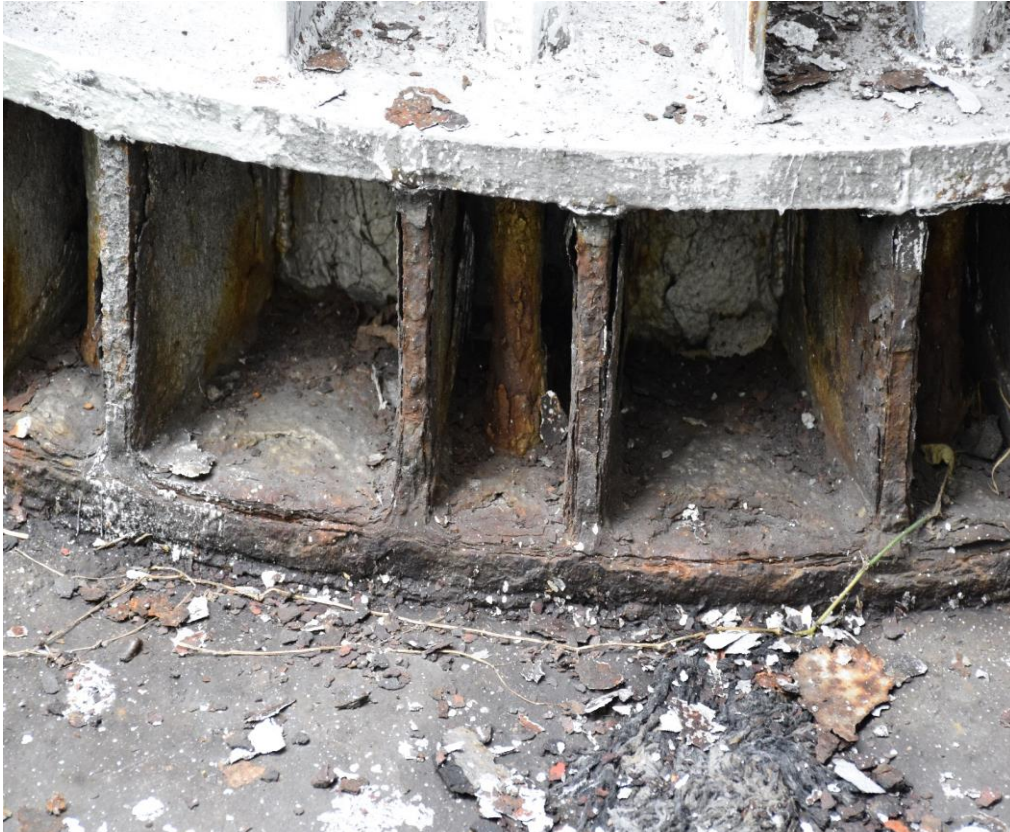
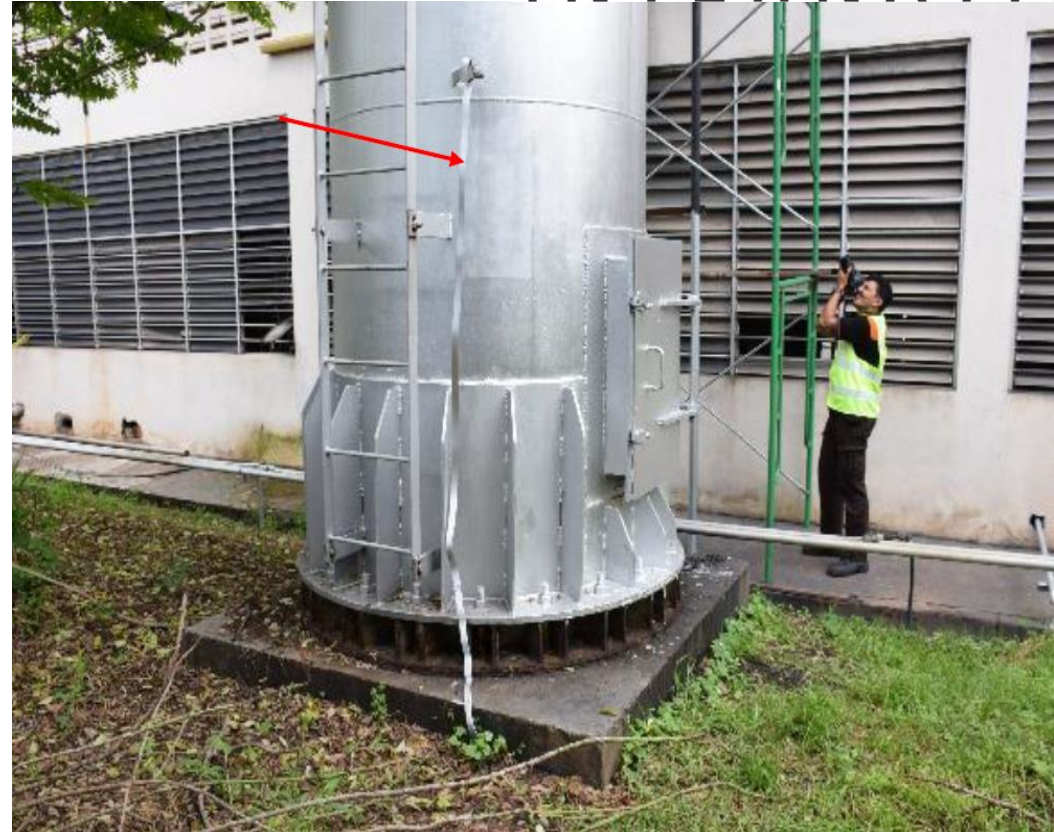
- Base of the chimney exhibited exfoliation corrosion
- The type of corrosion occurs over a period of years when the metal sections are exposed to humidity

- Thinning of chimney and ducting material provides clear evidence that the material has been deteriorating
- Strong wind has contributed to the damage however if the integrity of the material was not compromised it would not have been damaged

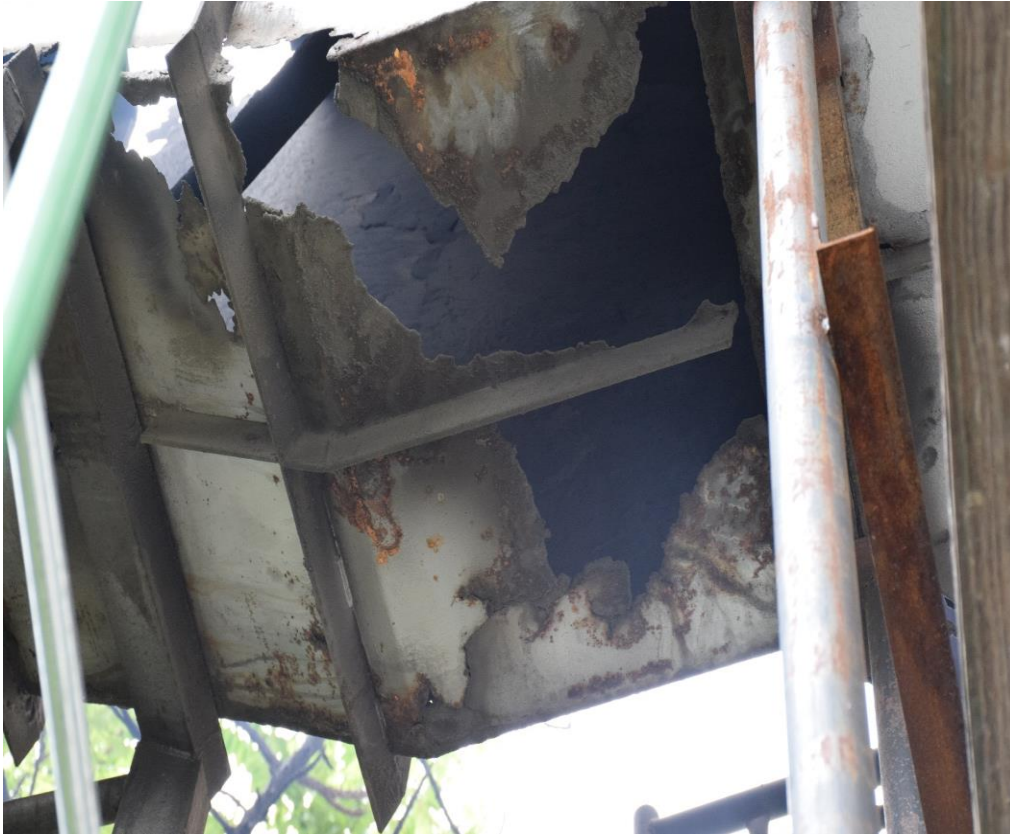
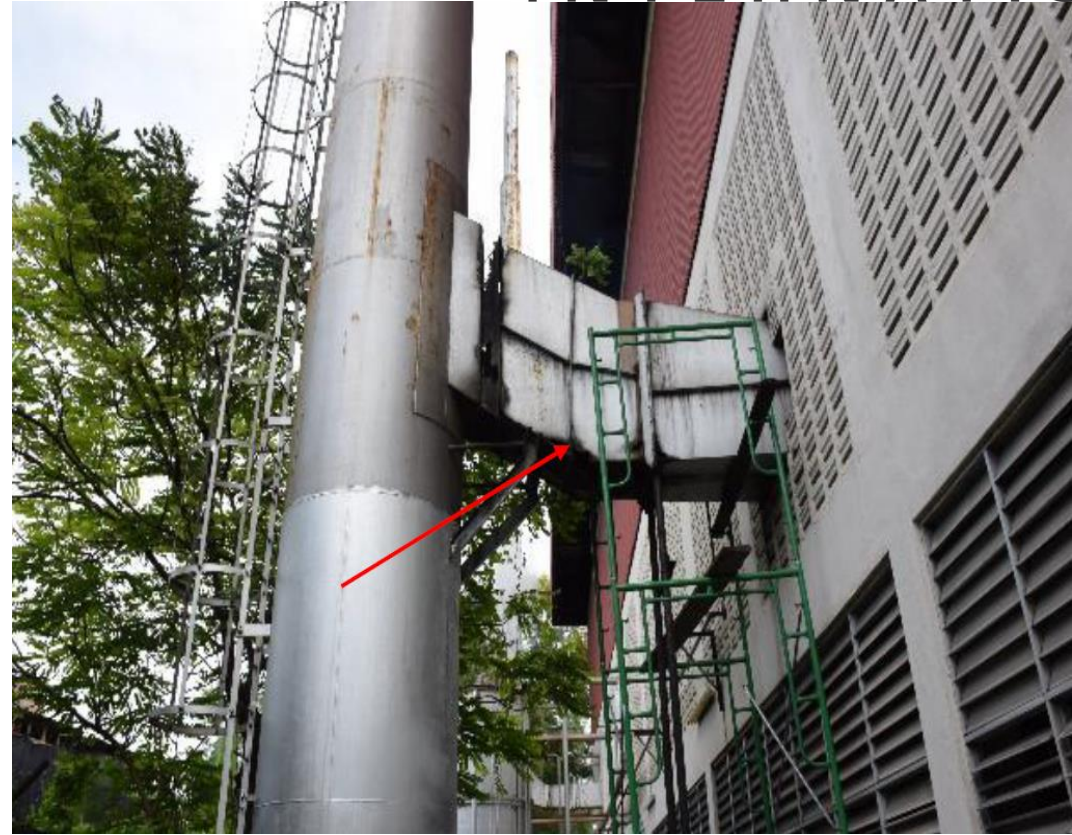
- Torn ducting which connects boiler ID Fan to Chimney
- Torn section exhibited heavy corrosion; thickness reduction of ducting material detected

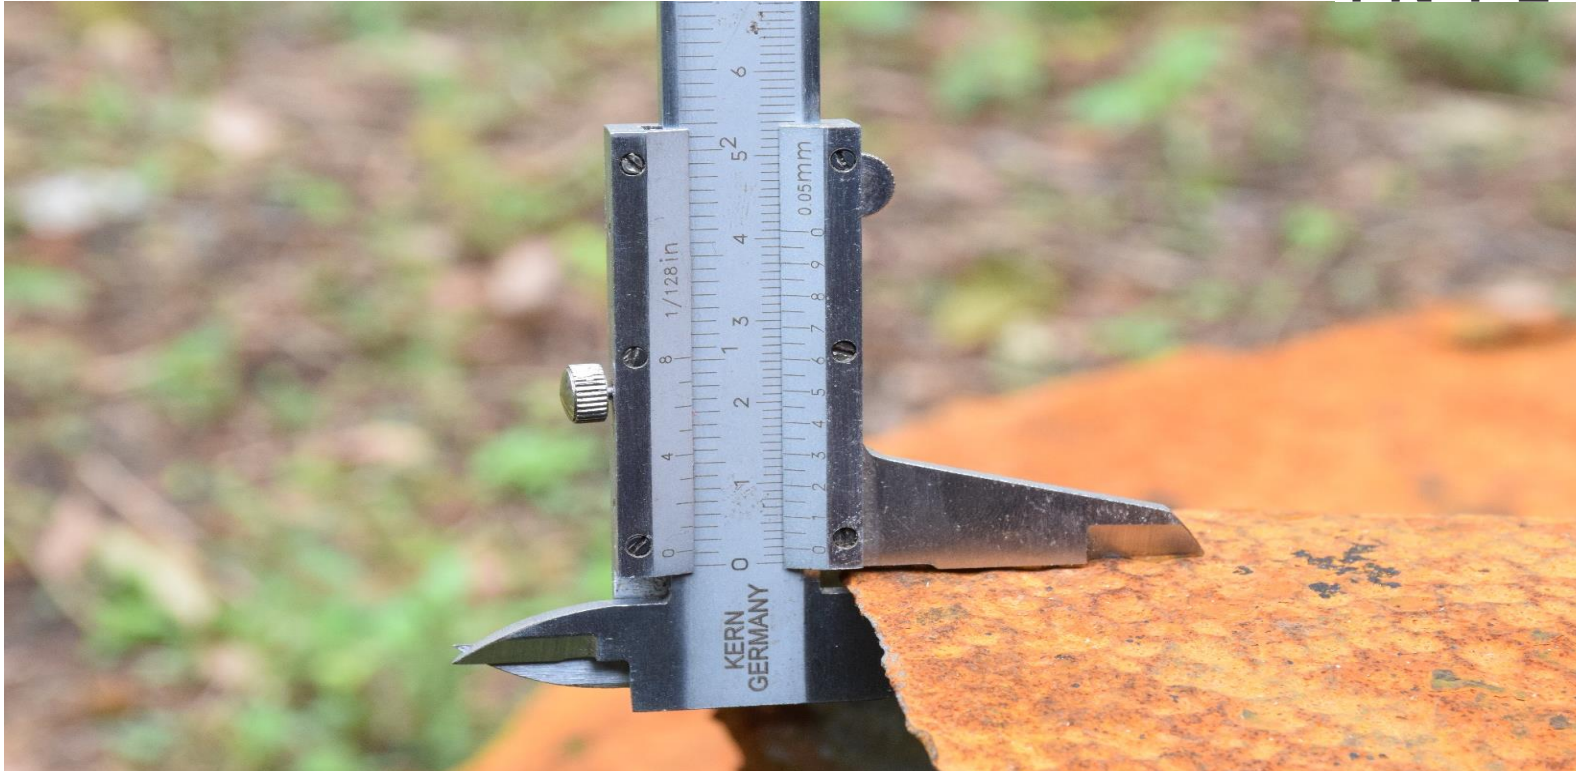
- Chimney top section thickness reading was measured at 1.85 mm
- Supposed thickness as per chimney specification is at 3 mm
- Approximately 38.3 % thickness reduction on chimney top section

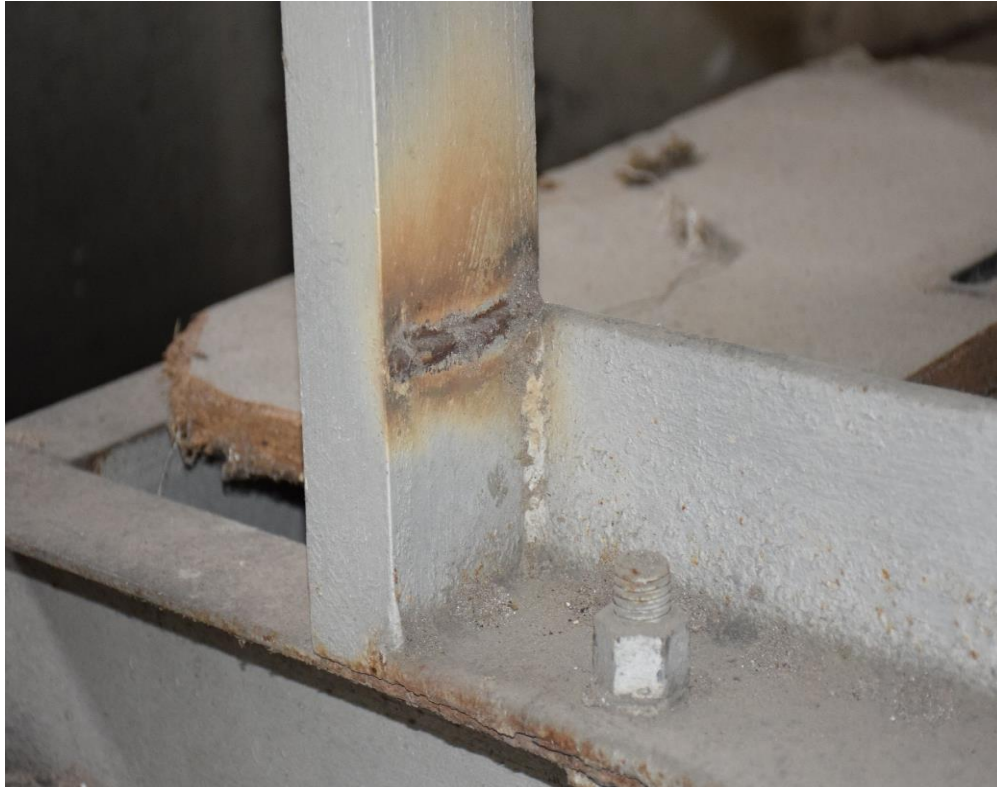
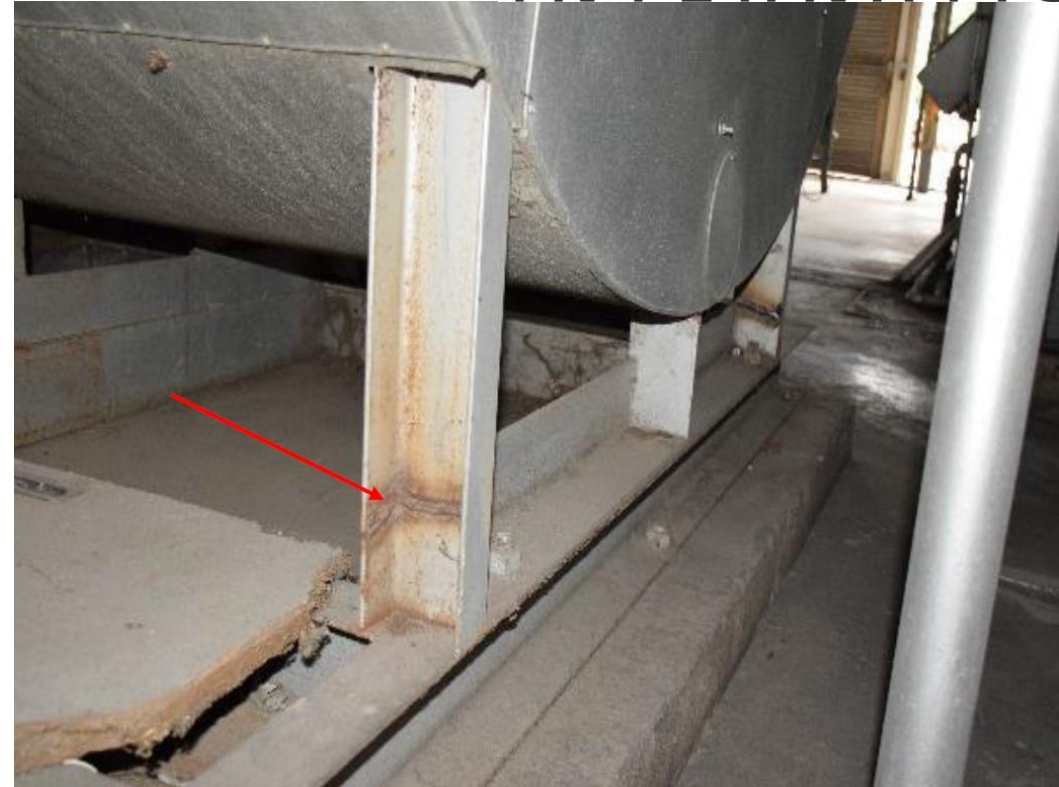
- ID Fan bottom support frame legs broken; broken section is right below motor side of the ID Fan
- Cracks observed were diagonal to heat affected zone of the weldment

- ID fan indoor, and no damage on indoor ducting
- Ducting damage only observed on outdoor ducting
- Hence, if wind was strong enough to damage the ID fan it would have damaged the ducting indoors as well
- Damage on just the frame legs on the impeller side shows that the crack was caused by excessive vibrations

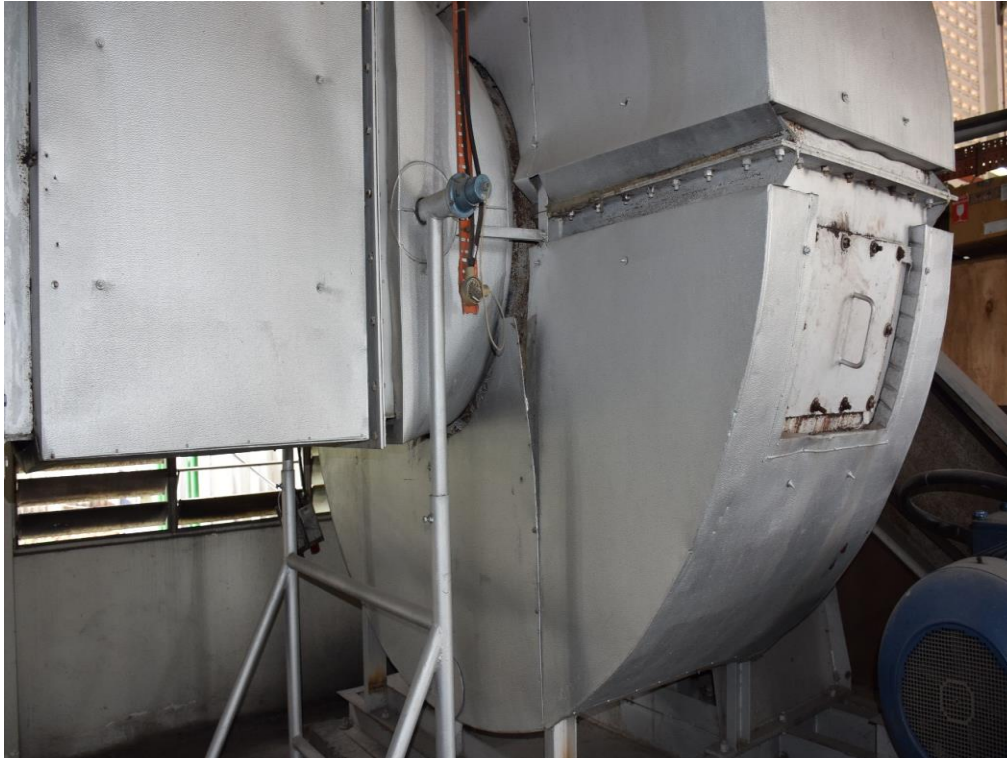
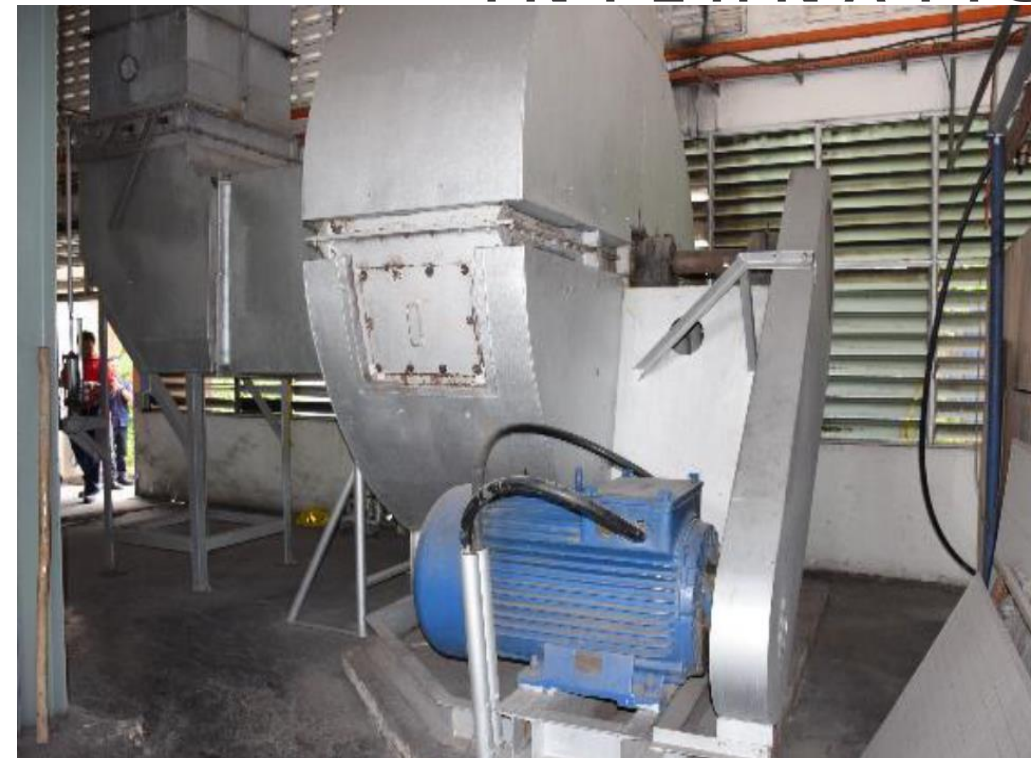
- ID fan imbalanced; as per maintenance record radial balancing was done
- No axial balancing was conducted to the ID Fan

- Balancing done after incident is radial balancing, happens when there is an imbalance in the impeller, due to dust accumulation or material loss on the impeller
- If wind loads have lifted the id fan and its ducting then it would affect both radial and axial balancing
- Just radial balancing raises a red flag

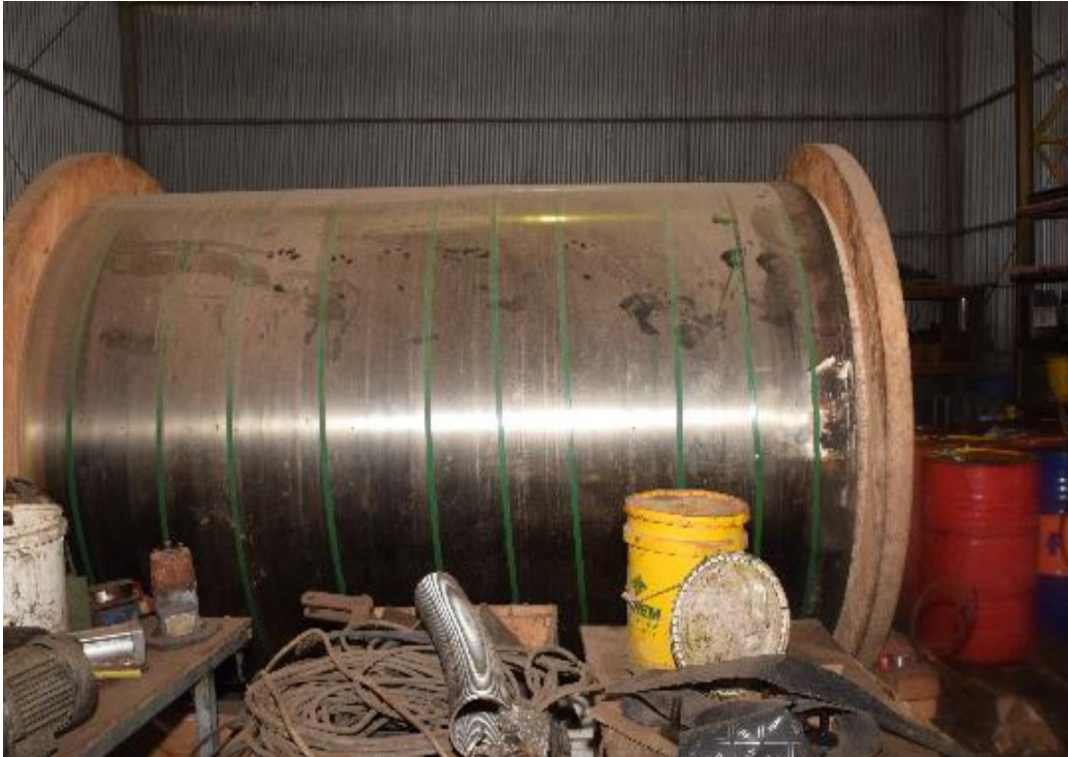
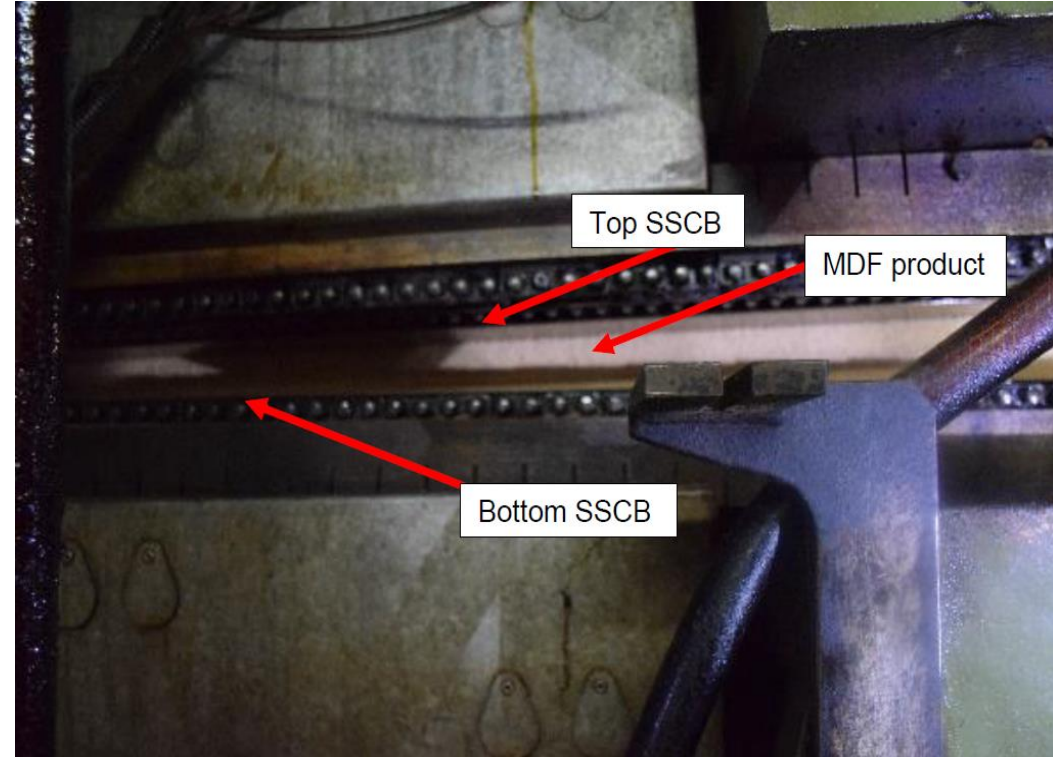
- Fire incident allegedly caused medium density fiber board pre-press machine's stainless steel conveyor belt (SSCB) to crack on its edges
- The SSCB was replaced and allegedly damaged SSCB was kept in storage

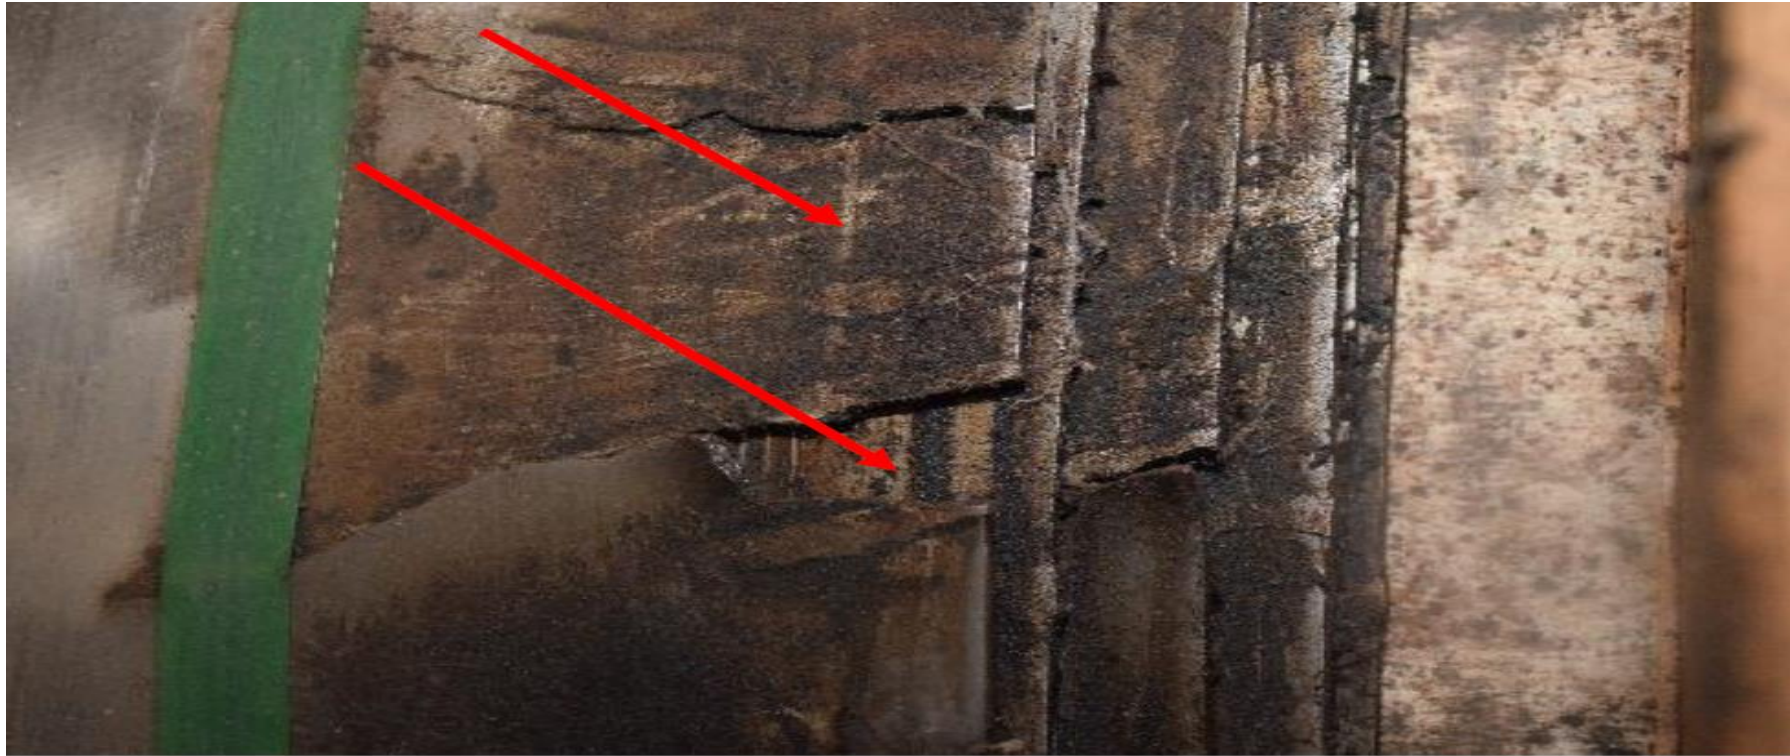
- The edges of the SSCB was observed to have cracked through out its length
- Length of the crack propagation was measured to be approximately same on each crack

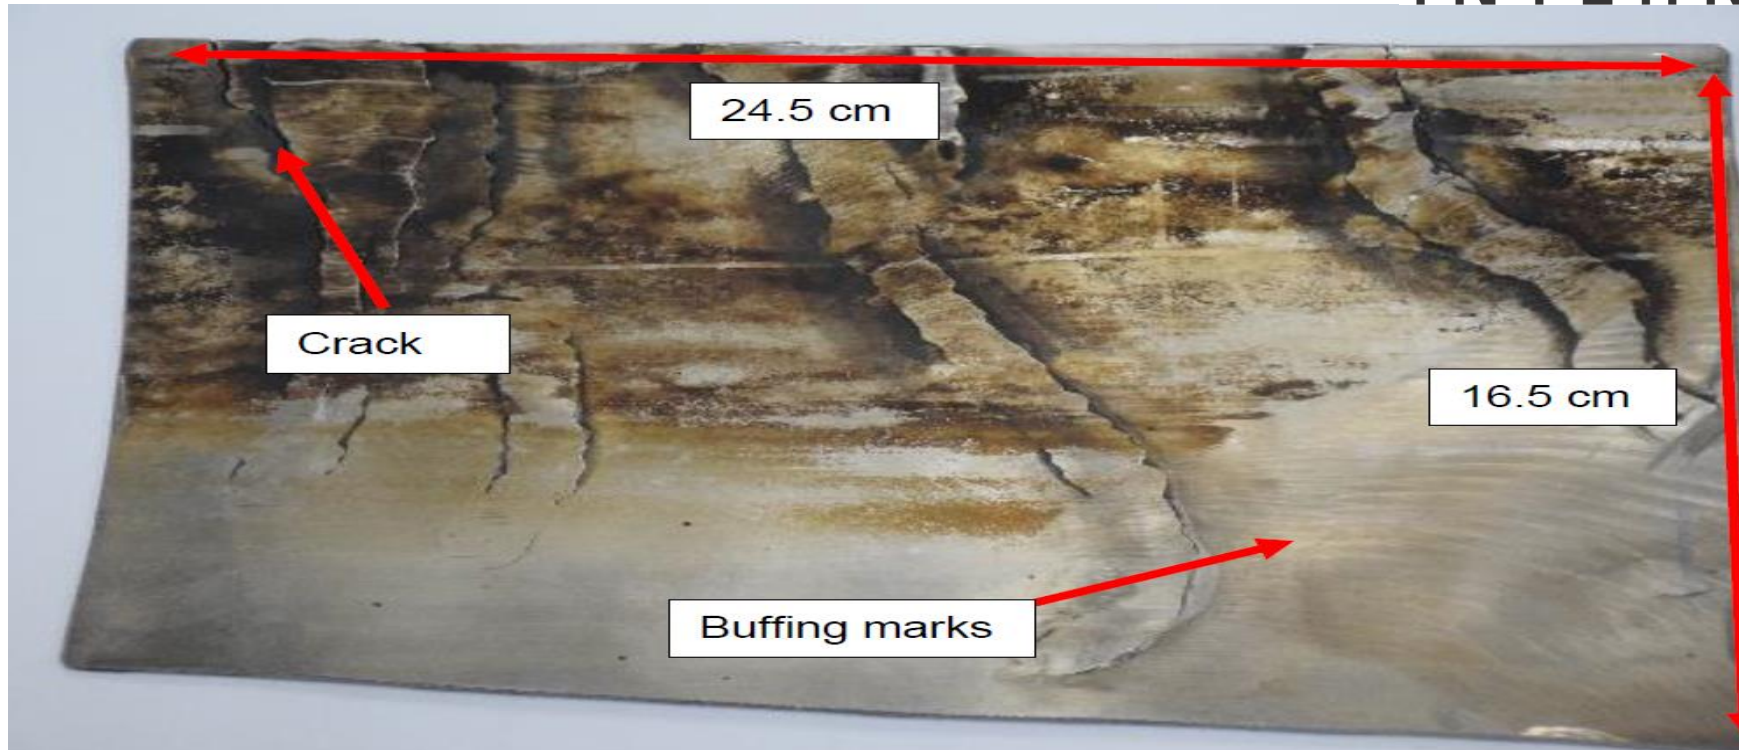
- A sample was cut out for further analysis from the SSCB
- Crack marks propagation was observed along a line similar to welding
- Buffing marks were also observed on the SSCB sample

- The fire if at all did occur, cannot damage the stainless steel conveyor belt
- Damage analysis on the sample obtained revealed that the damage seen is a pre-existing damage which was welded by the insured
- The fire incident was used to exaggerate the claim
