Engineering Fraud Claims

12 August 2021

G SUJENTHIRAN

CHIMNEY COLLAPSE

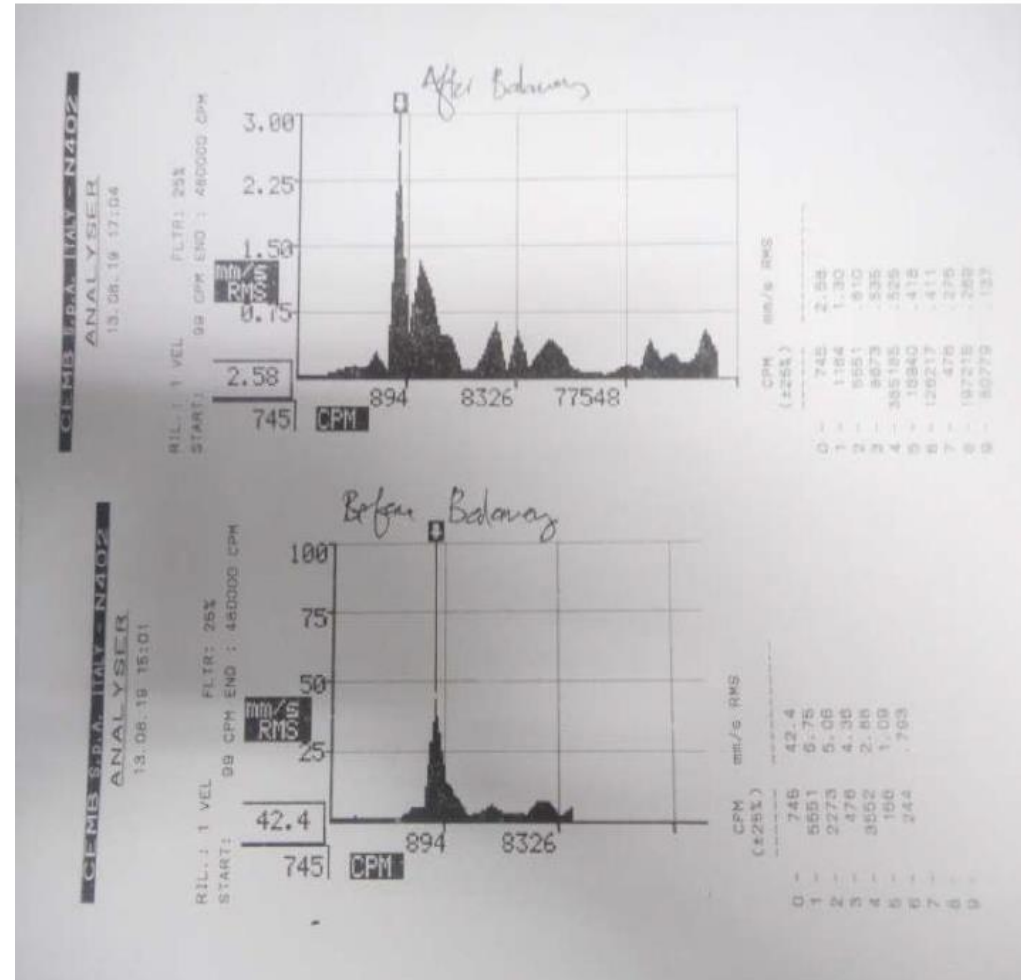
CHIMNEY COLLAPSE (Analysis)

- Balancing done after incident is radial balancing, happens when there is an imbalance in the impeller, due to dust accumulation or material loss on the impeller
- If wind loads have lifted the id fan and its ducting then it would affect both radial and axial balancing
- Just radial balancing raises a red flag

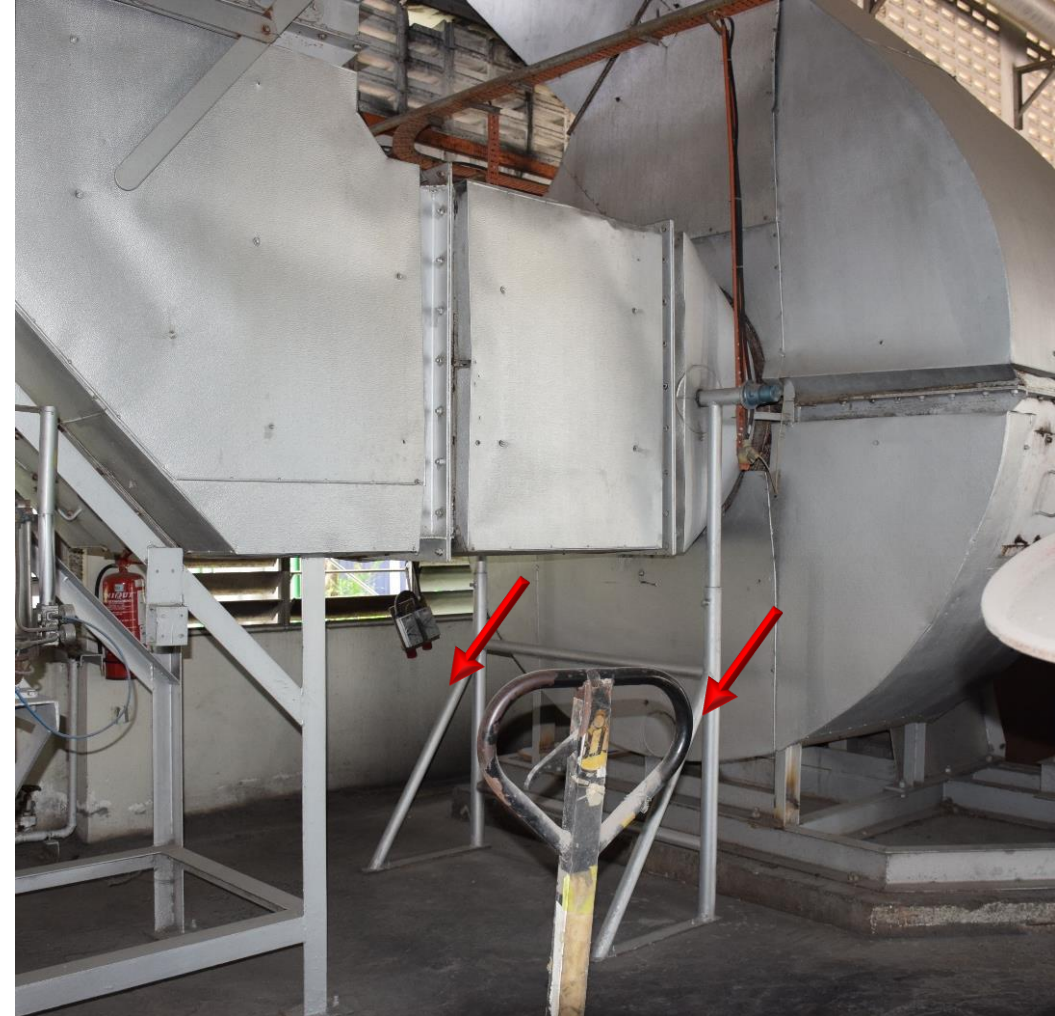
CHIMNEY COLLAPSE (Analysis)

- ID fan indoor, and no damage on indoor ducting
- Ducting damage only observed on outdoor ducting
- Hence, if wind was strong enough to damage the ID fan it would have damaged the ducting indoors as well
- Damage on just the frame legs on the impeller side shows that the crack was caused by excessive vibrations

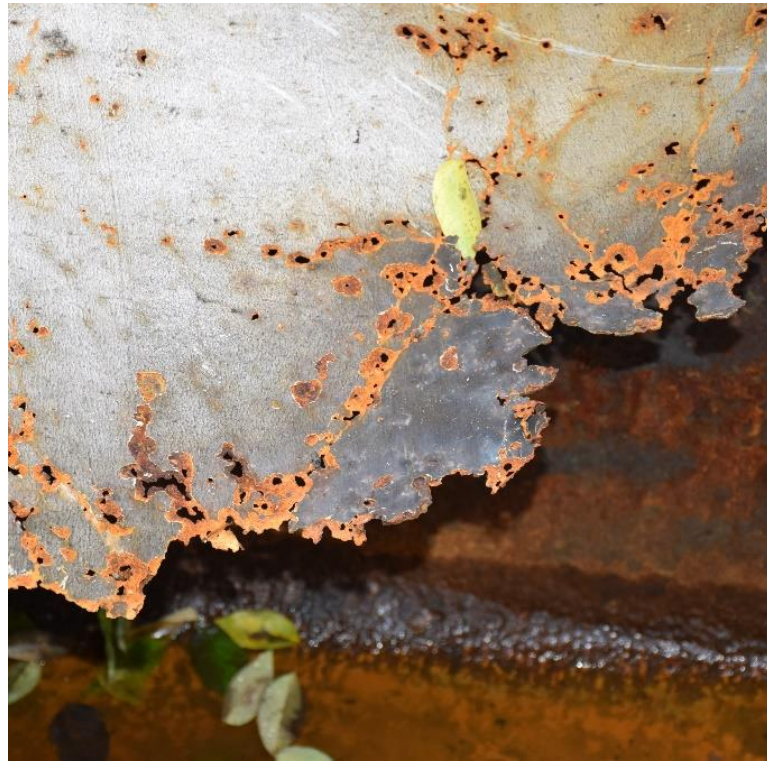
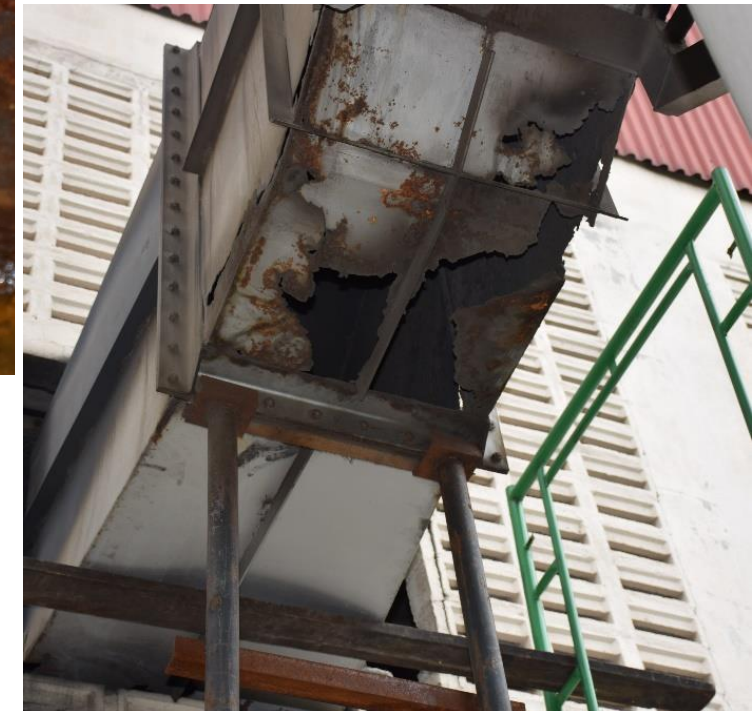
CHIMNEY COLLAPSE (Conclusion)

- Thinning of chimney and ducting material provides clear evidence that the material has been deteriorating
- Strong wind has contributed to the damage however if the integrity of the material was not compromised it would not have been damaged

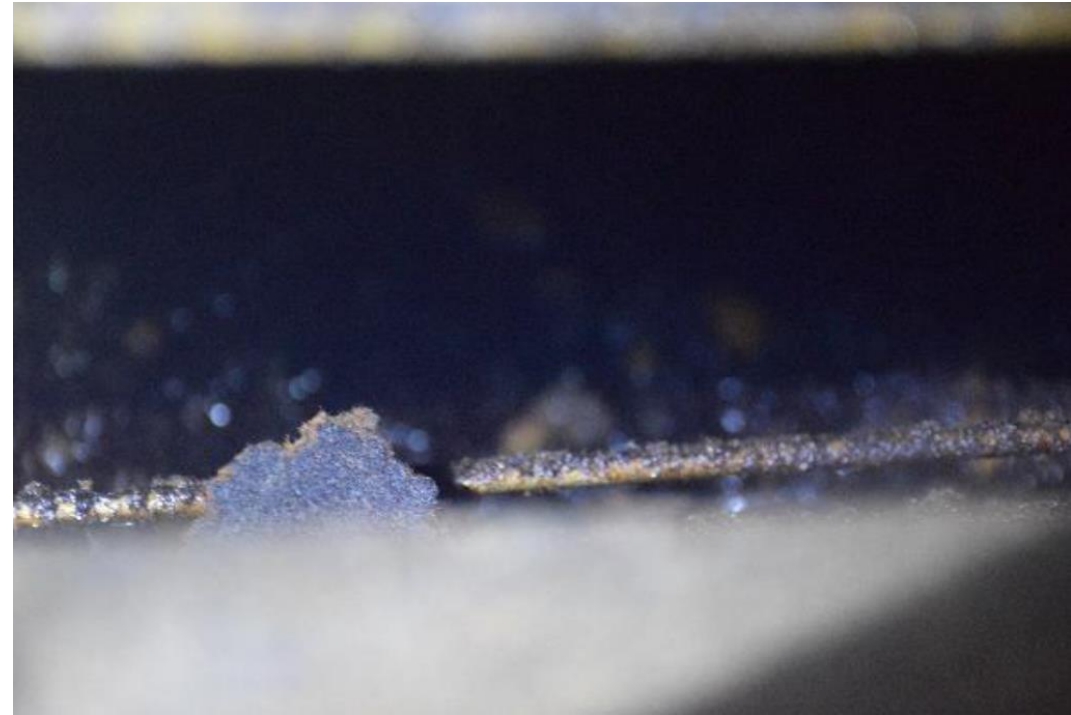
FIRE

Stainless Steel Conveyor Belt Fire Damage (Analysis)

- The next available fuel load was the MDF board debris and the MDF board itself
- The auto ignition temperature of MDF was stated by multiple MDF MSDS to be at 475°F (246°C)
- Therefore, the initial fire fueled by grease needs to burn for a certain period of time till it can convey enough energy for MDF to burn

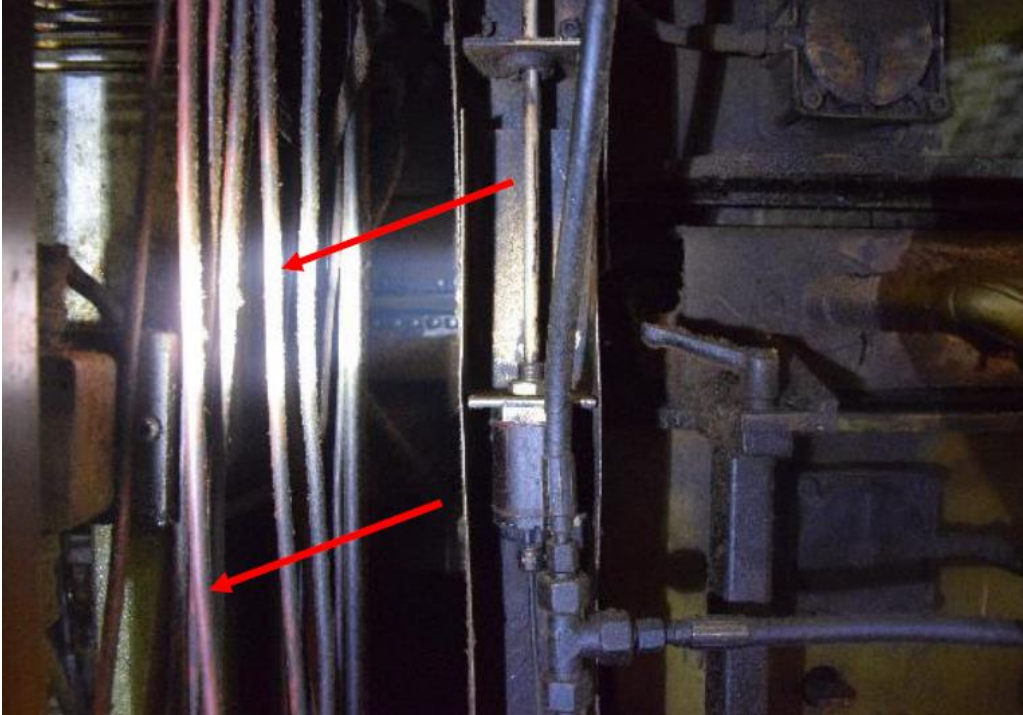
Stainless Steel Conveyor Belt Fire Damage (Analysis)

- Stainless steel service temperature is ranging from 600 °C to 1150 °C
- From the observation of alleged section of fire occurrence, no signs of temperature being above the state service temperatures
